POLICE STATION – SAFWAN IHP
404
BASRAH, IRAQ

PROJECT NUMBER SIGIR-PA-06-051
JULY 24, 2006

SUBJECT: Report on Project Assessment of the Safwan Iraqi Highway Patrol
Construction, Safwan, Iraq (Report Number SIGIR-PA-06-051)

Police Station – Safwan IHP 404, Basrah, Iraq

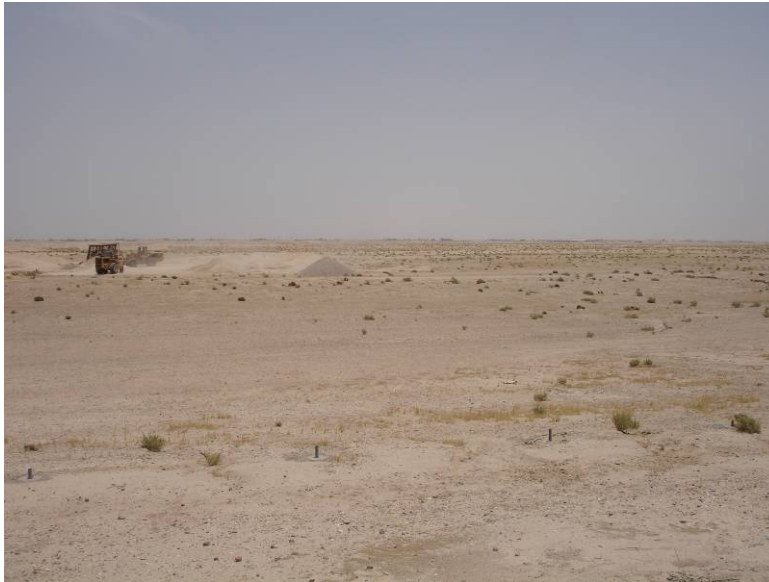
Site Photo 1: IHP Barracks project site during initial construction (Photo courtesy of the USACE)

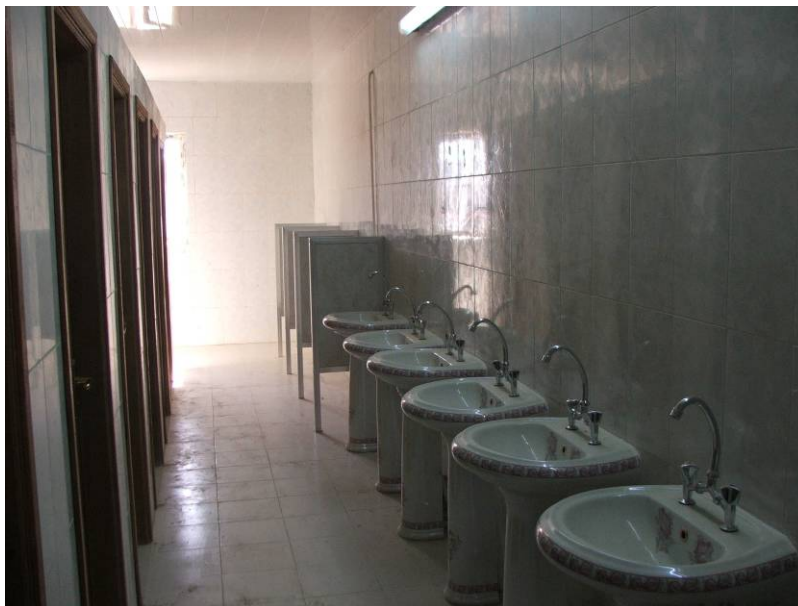
Site Photo 4: Bathroom facility

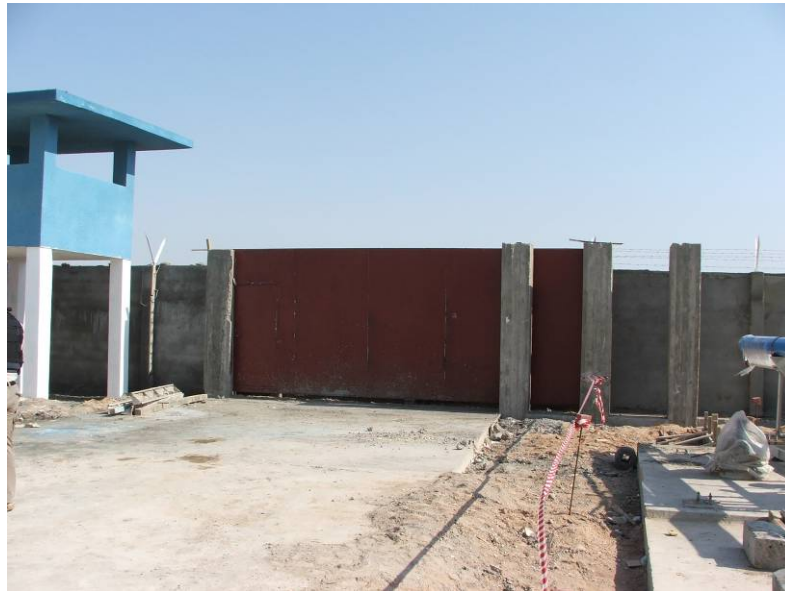
Site Photo 8: Rear entrance gate

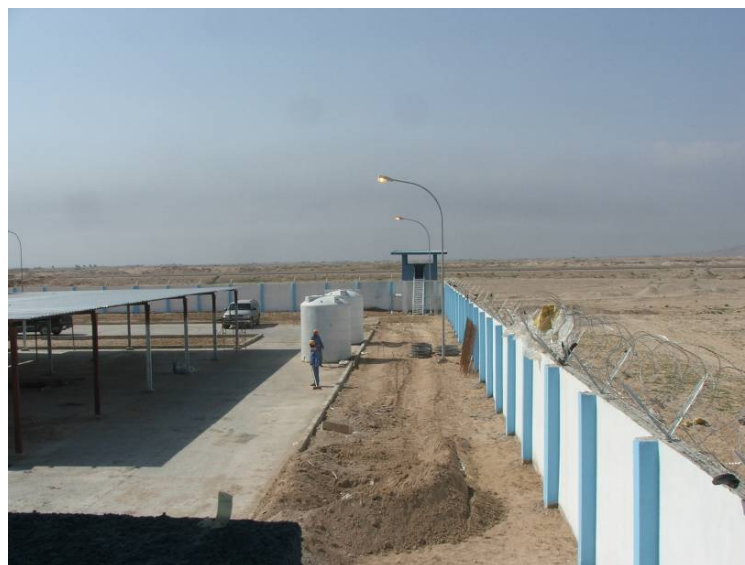
At the time of the assessment, three 8-meter light poles and none of the 4-meter light poles were observed installed. During the site visit electrical testing was being conducted with the use of a portable generator and the light poles were observed to be operational. Exterior building wall mounted lights were observed at entry ways. The guard tower outward orientated lights were not evaluated. Site Photo 9 shows installed 8-meter light poles with the lights illuminated, and Site Photo 10 shows the installed exterior building lights.

Site Photo 9: 8-meter light poles

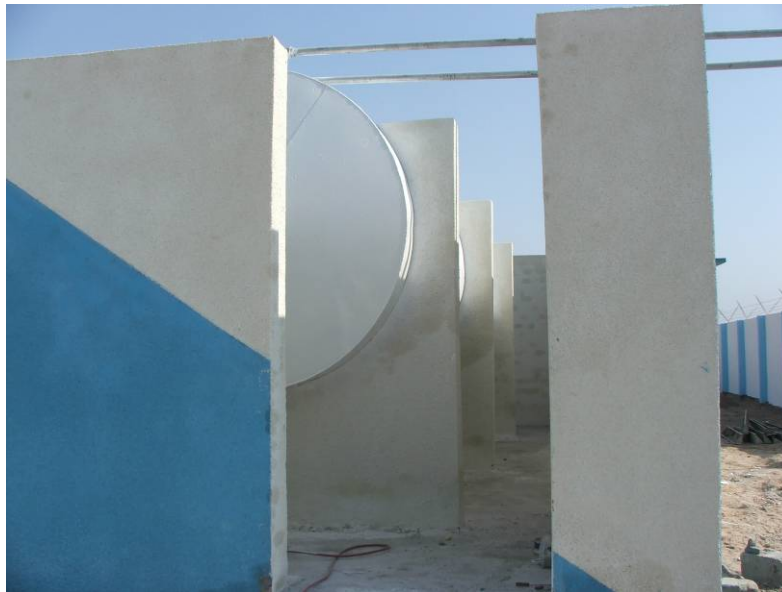
At the time of the assessment, the fuel tanks and the fuel dispensing units were in place, although these items had not been completely tied in. Two steel horizontally mounted fuel tanks were observed located within an enclosed wall system. The fuel tanks were supported by a concrete cradle system and also by steel supports. Piping had been installed and two fuel dispensing units were located on a concrete pad. The framework for a steel framed cover was complete over the fuel dispensing units, although the roof had not been installed. The fuel tanks and piping were consistent with the contract and design requirements. Site Photo 12 shows the end of one of the fuel storage tanks and wall enclosure, and Site Photo 13 shows the fuel dispensing units.

Site Photo 12: Fuel storage tank with wall enclosure

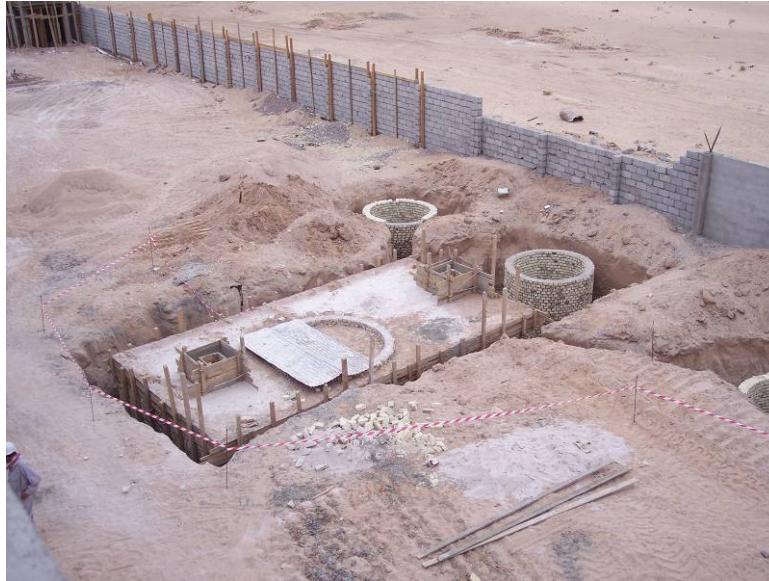
surface where the septic system was installed. Site Photo 16 shows the septic system during installation (courtesy of USACE) and shows tank and leech pits.

Site Photo 16: Septic system during installation (Courtesy of USACE)

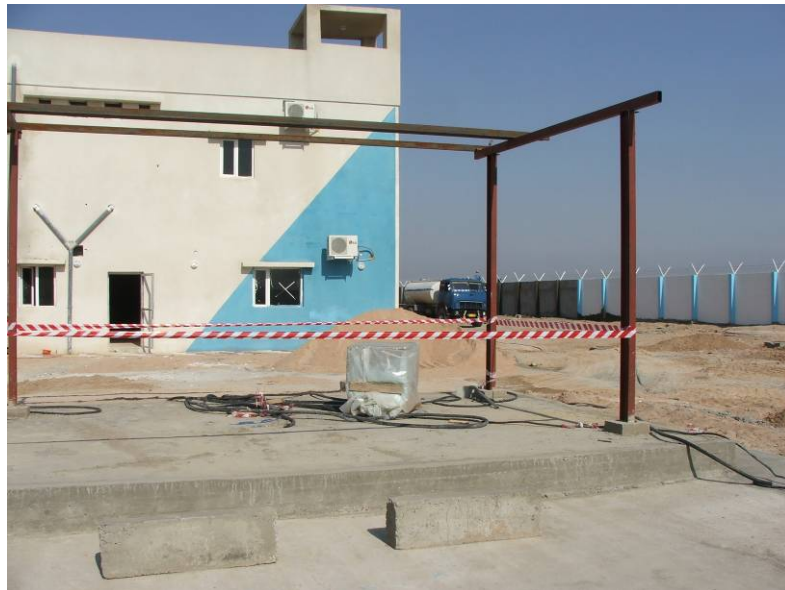
Site Photo 17: Concrete pad for generator unit
